HISTORIC STRUCTURE REPORT

THE A.W. PERRY HOMESTEAD MUSEUM

CITY OF CARROLLTON, TEXAS

November, 2020

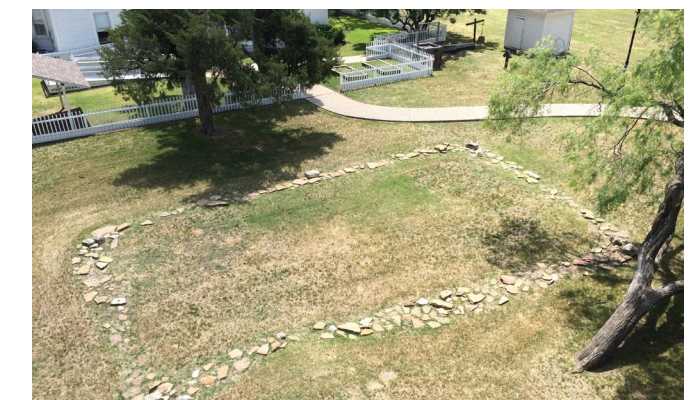
— Image above shows the original foundation outline still visible behind the main house

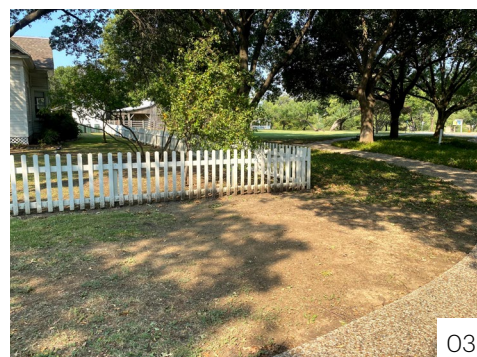
Outside the picket fence line at front entry near historic markers, shade prevents growth of turf and dirt is exposed. Rain and irrigation patterns cause dirt to collect on the lower portion of the picket fence. Shade tolerant ground cover or mulch in these areas would help the aesthetics of the front approach. Image 03

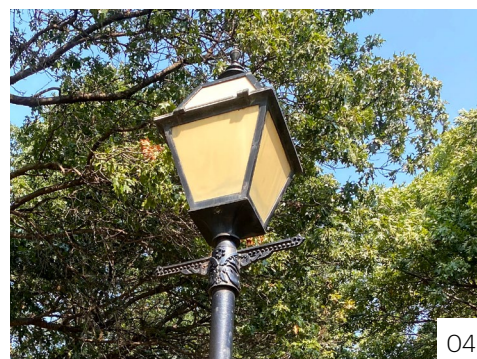
Light posts around the Farmhouse could use inspection and possible replacement of acrylic covers, yellowed from UV exposure. Image 04

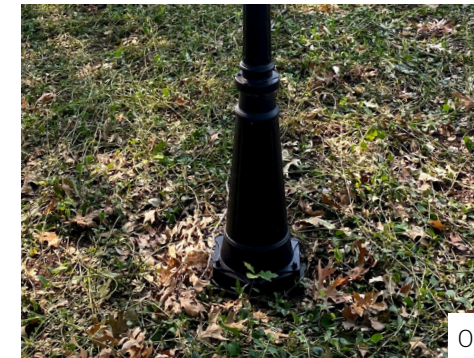
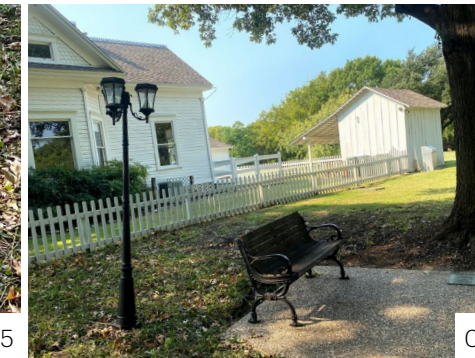
The base of the light post at the Gravelly Tree Marker is loose and needs to be secured. Images 05 & 06

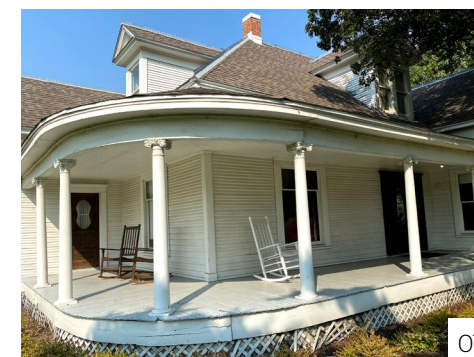
Roofing: Existing composition roof and flashing appears in overall good condition. Buckled shingles are evident around the edge of the curved front porch roof. All edge flashing and flashing around dormers should be inspected and repaired as needed. Image 07

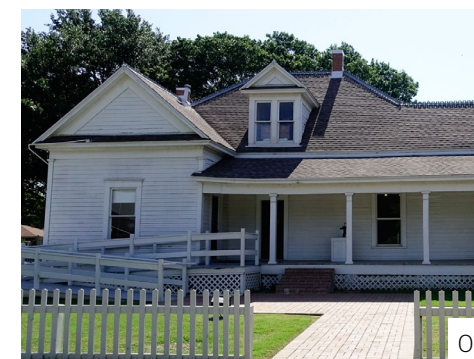
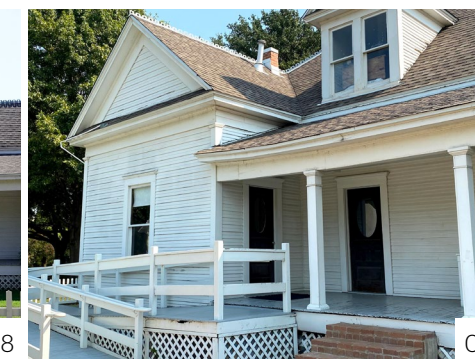
The northwest end of the West Back Porch beam and roof appears to be curving upward. This should be examined and repaired if possible. Image 08, 09

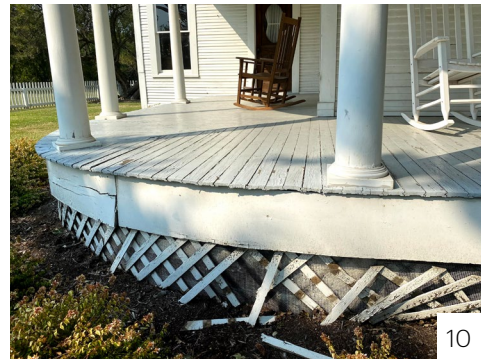
Foundation insect screen and lattice has deteriorated and needs replacement. Alternative materials are recommended in lieu of lattice, which would not have been used at the time of significance. Removing existing lattice and installing a tight welded wire mesh (for rodents) & insect screen around the perimeter is recommended. Foundation piers could be painted or covered, depending on the appearance after removal of lattice. Image 10, 11

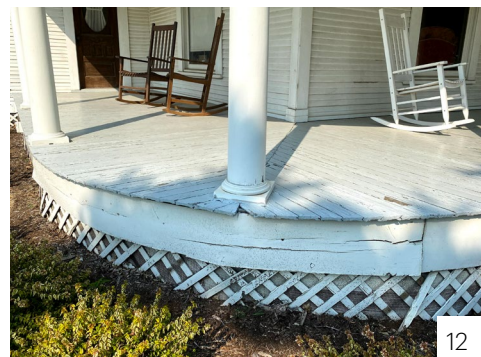
East Front Entry Porch Columns are in relatively good condition. Gentle cleaning is needed to remove dirt from capitals and columns. The bottom ends of the round columns show swelling and peeling paint, due to exposure to weather. Peeling paint should be removed, wood examined and treated to prevent decay, and columns should be patched, primed and re-painted. Image 12

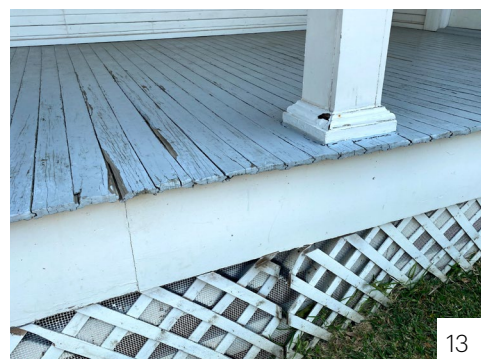
West Back Porch Columns have separated in some locations and the base molding needs to be repaired or replaced. Image 13

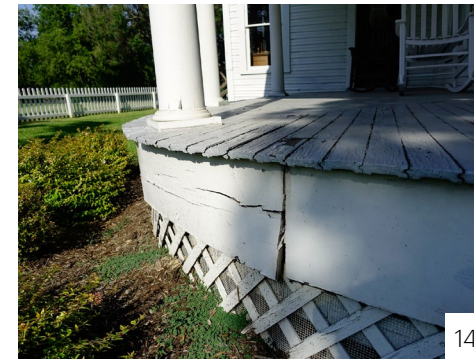
All porch base trim board joints are warped and visible at the curved porch beam and underfloor boards around perimeter of porches. Curved board skirting below the front porch floor-boards should be replaced, due to deteriorated condition. This is not original material. Image 14

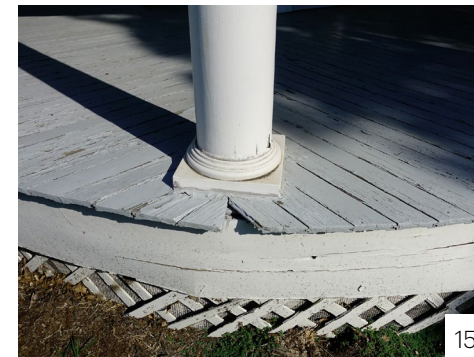
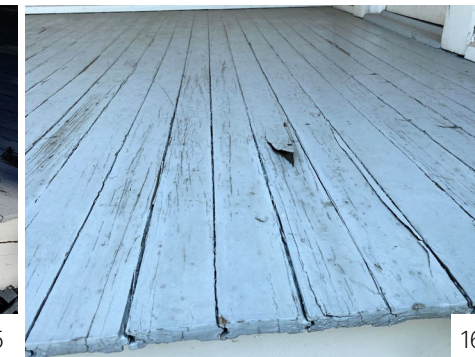
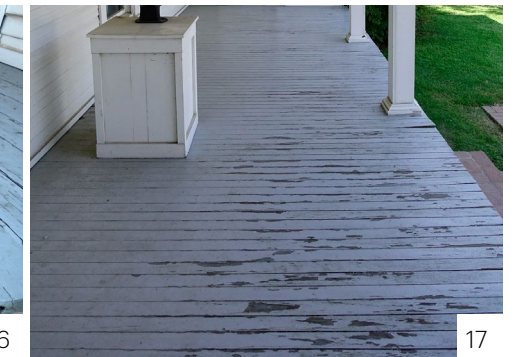
Porch floor-boards should be examined for rot and decay and replaced if necessary (for safety) with matching material. Existing paint should be lightly scraped and removed before re-painting. Priming the underside of porch boards is recommended. Boards that have lifted at the edge should be re-secured. Image 15, 16, 17

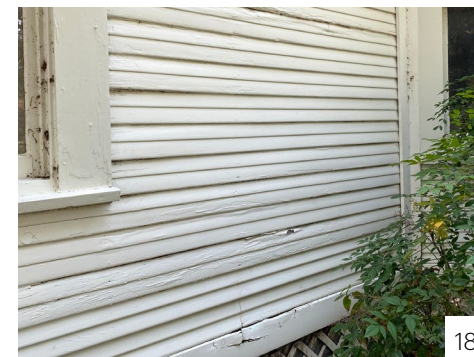
Siding and trim should be cleaned and loose paint lightly scraped to provide a smooth bondable surface. Caulk has been applied between the weather board siding. This method should not be repeated. Paint to further protect the wood from damage. Image 18, 19

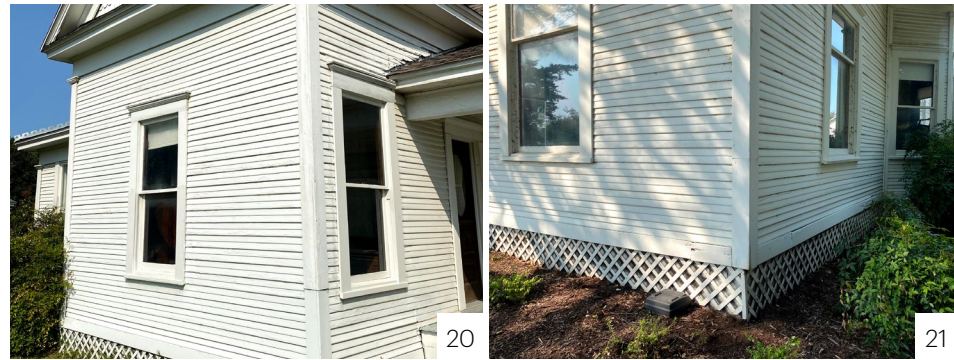
Corner trim boards were cut and replaced during previous repairs, and joints have separated. Replacement of lower trim board sections with concealed cut joints are recommended. Image 020, 021

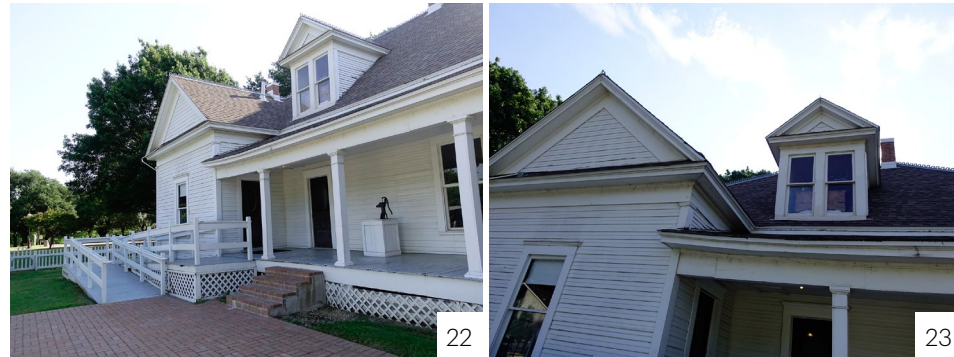
West-facing dormer sill needs treatment or replacement. Check others for rot. Image 022, 023

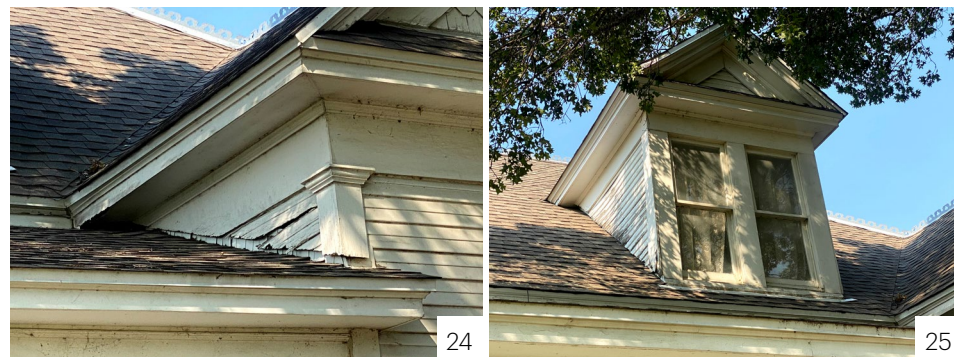
Evidence of deterioration and decay is apparent at all wall to roof connections, including porches and dormers. Rotted boards should be replaced, and end grain should be primed to extend life of the siding. Flashing should be checked for weathertight enclosure and repaired as needed. Image 024, 025, 026, 027,

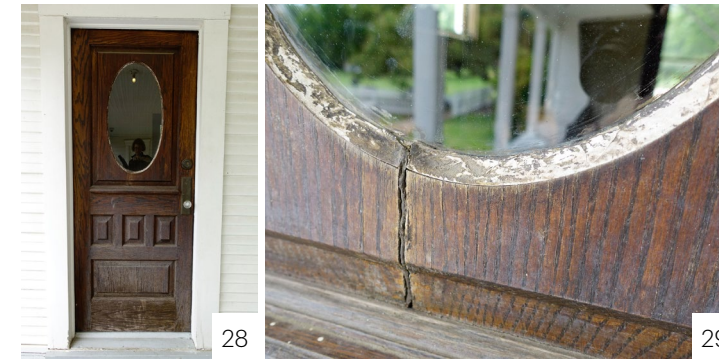
Kitchen Door wood panel supporting glass is cracked at the lower middle and shows evidence of prior repair attempt. Glazing is deteriorated. Image 028, 029

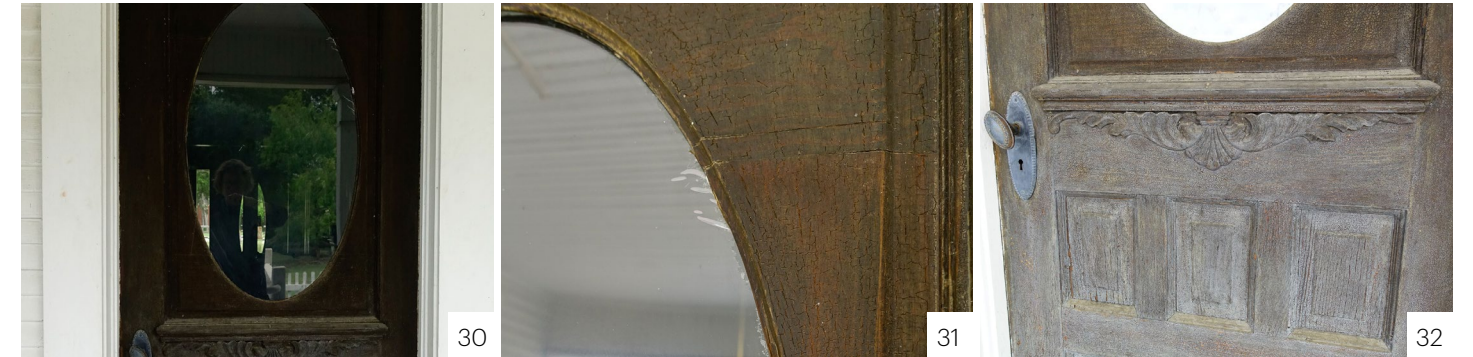
Stair Hall Door glazing is deteriorated, and there are visible cracks around the edges of the glass. Image 030, 031, 032

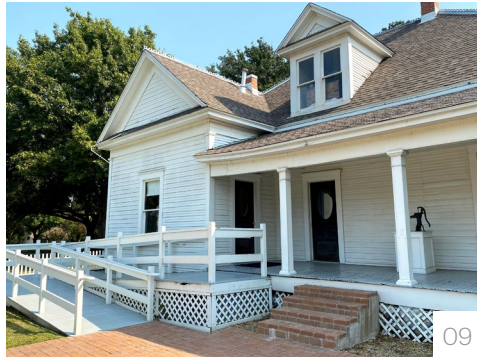
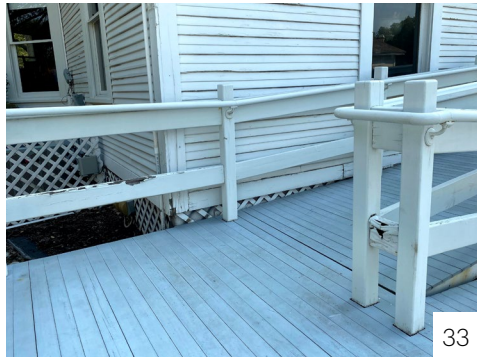
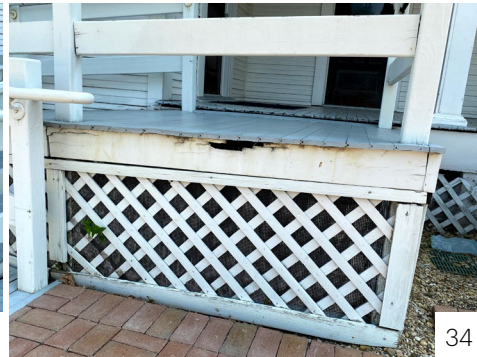
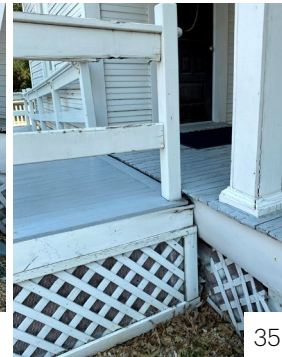
The wood ramp installed in 1980's shows areas of wear and decay, mostly visible on guard rails and framing boards. Wood floor-boards are painted gray to match the porches and are in relatively good condition. If replacement is considered, an alternate ramp design would be recommended, to allow separation and a more subtle connection, further distinguishing 1909 Farmhouse from modern improvements. The current adjacency of the ramp to the back of the Farmhouse prevents observation of the actual wall at the house at this juncture. Image 09, 33, 34, 35

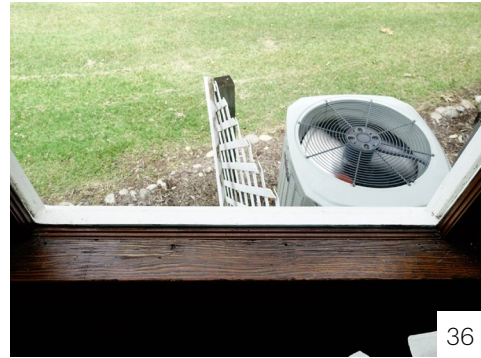
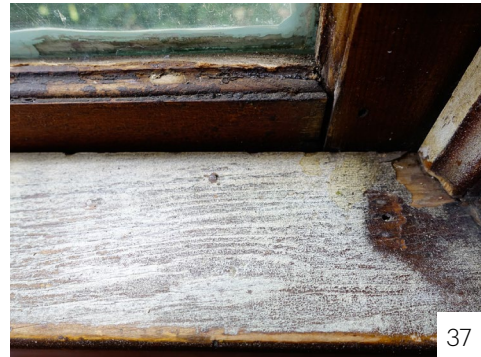
36

Windows: Interior wood sills have water damage due to window condensation. Sashes also have damage for the same reason. Interior sills and sashes could be protected with penetrating stain/sealer. Image 36, 37, 38, 39

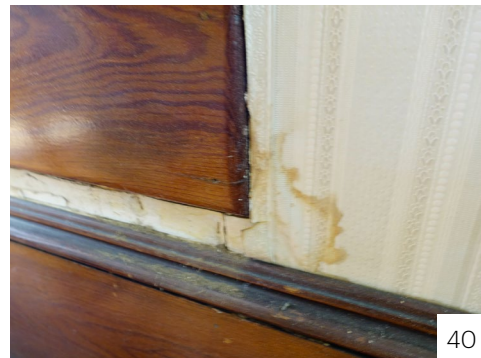
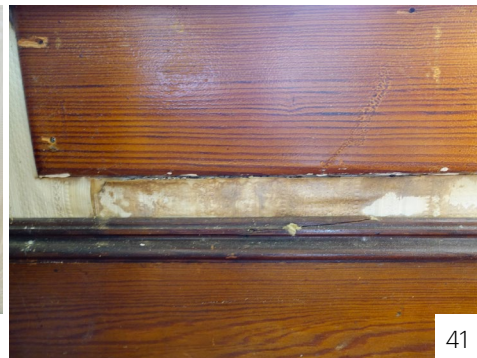
40

Water damage is apparent on the walls below bay windows in Dining Room. Window seal should be examined and repaired if needed. Interior wood window sills show signs of water damage. A possible solution could be to prevent condensation or leakage. Image 40, 41

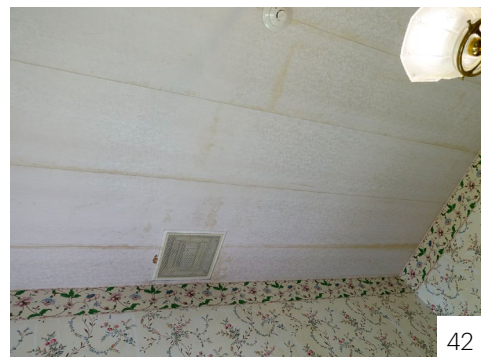
Water damage is apparent on the ceiling wallpaper of South Bedroom, near the vent above south window. Condensation or water penetration should be stopped and a section of paper could be removed and replaced – or the damaged paper could be cleaned and left in place if original. Image 42

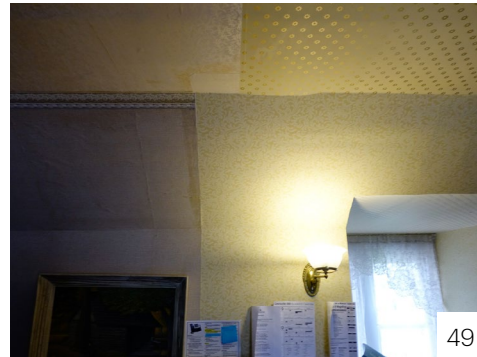
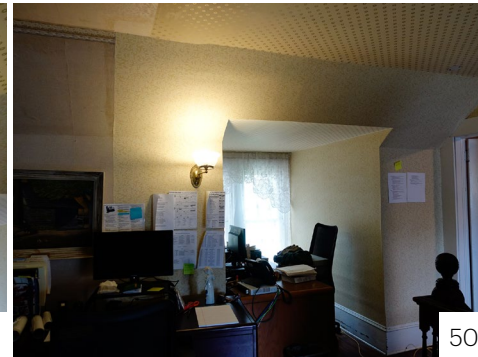
Rodent activity was observed. (ITO report Attic #3)

Improve attic ventilation. (ITO report Attic #5)

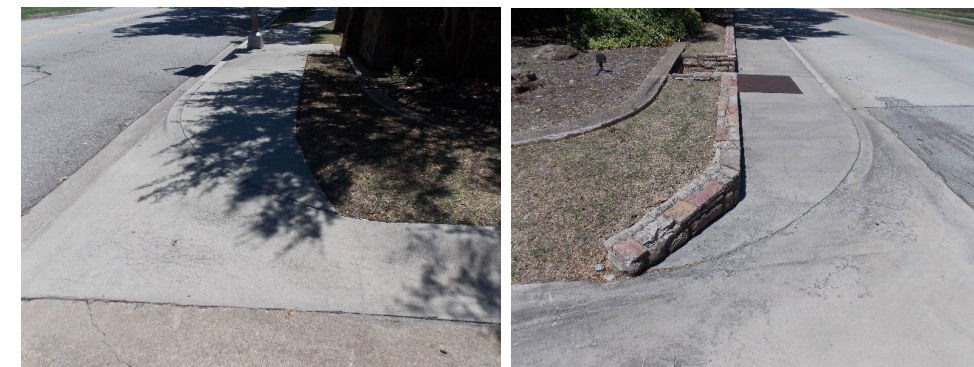
(Perry Drive Sidewalk)

The adjacent sidewalk along the west edge of Perry Drive is part of the public network of accessible routes (TAS 206), and its cross-slope and running slope along the study area appear to be within the 2% and 5% maximum slopes respectively. Paved pedestrian site access ends at the two approaches of the sidewalk to the vehicular driveway. It is noted that from the public sidewalk along Perry Drive there are no site arrival points that connect to exclusively pedestrian route(s) into the property; rather a pedestrian must turn into and use the vehicular driveway which is an unsafe condition that should be eliminated.

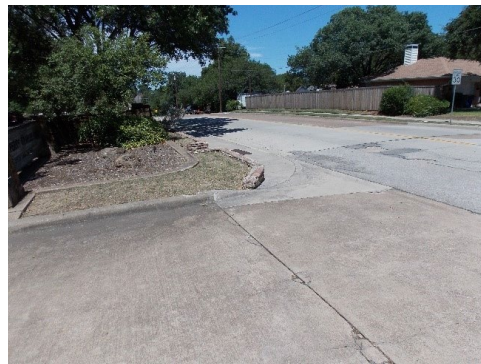
(Vehicular Driveway Entrance)

The driveway “dustpan” allows for unsigned, non-sigaled pedestrian crossing of the driveway, however, it has a cross slope that exceeds the maximum 2% allowed. This condition is typical of many driveways, yet it must be noted that at the entrance driveway it means that the accessibility of the sidewalk ends and does not extend across the driveway. An excessive cross slope in the vehicular entrance pavement intended for wheelchair users creates a potentially dangerous condition, particularly if sloped toward the street and in situations where the wheelchair user does not have complete control of their device.

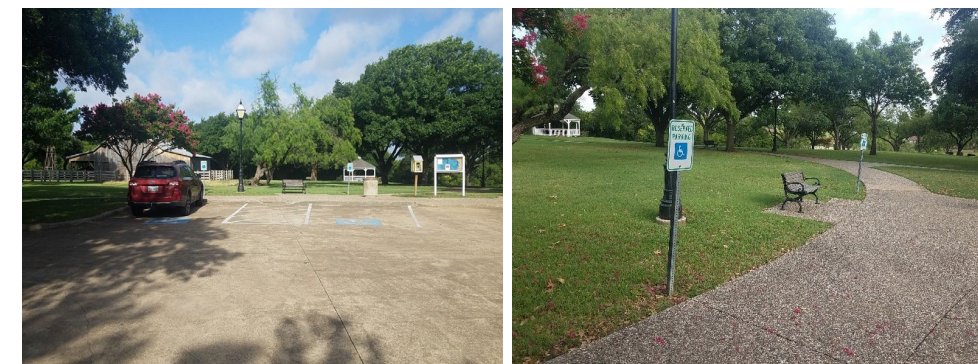
(Accessible Parking Stall Demarcation)

The painted striping and universal accessibility symbols painted in the stalls are visible but are worn and fading.

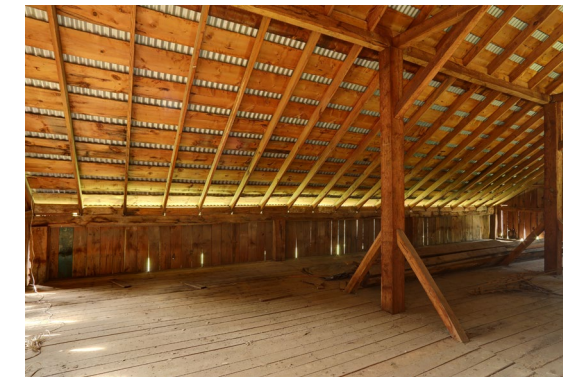
Photo #1

Roof joists (2x6 at 24" on center) appear to be inadequately sized to resist code-required roof live loads and wind loads. Connection of the joists to the supporting beams is not adequate to resist wind uplift forces.

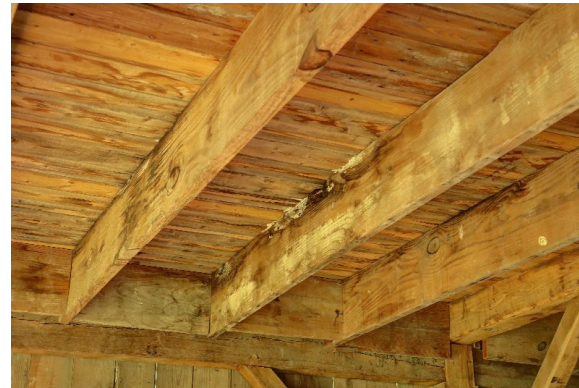
Photo #3

Floor joists (2x12 at 24" on center) appear to be close to adequately sized to support a reasonable design live load, but their condition (note water damage in photo) and their sharply-notched ends compromise their load-carrying capacity (see photo 4).

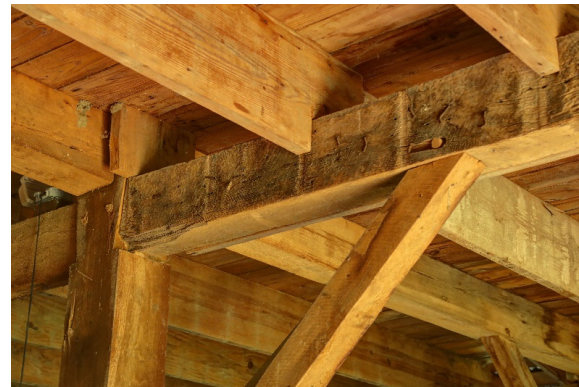
Photo #4

Roof beams (6"x8") appear to be inadequately sized to resist code-compliant floor live loads.

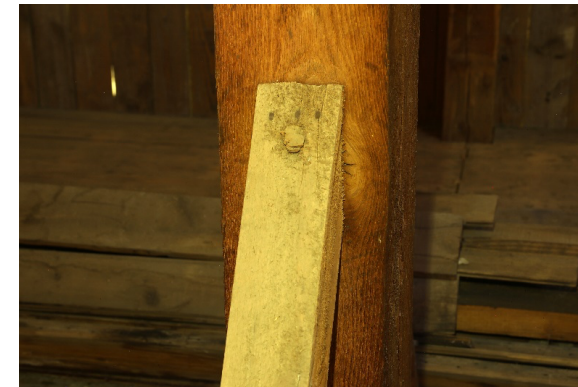
Photo #7

Diagonal bracing connections at some brace-to-column connections do not appear to be substantially fastened. This wood dowel appears to be located very close to the end of the diagonal, and passing through a very thin end condition in the diagonal, supplemented by 3 nails.

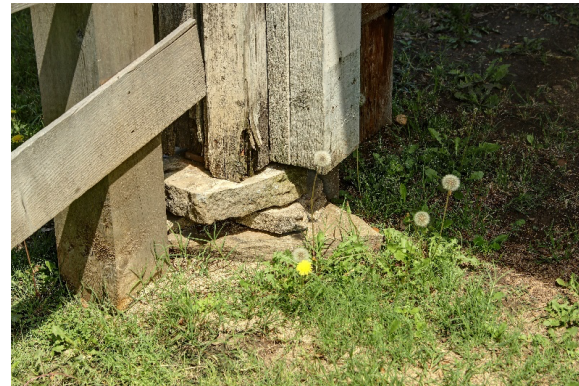
Photo #9

Wood columns, especially perimeter columns, have been subjected to long-term exposure to the effects of weather and are showing signs of deterioration. The bases of these columns need repair or replacement.
