HISTORIC STRUCTURE REPORT

THE A.W. PERRY HOMESTEAD MUSEUM

CITY OF CARROLLTON, TEXAS

November, 2020

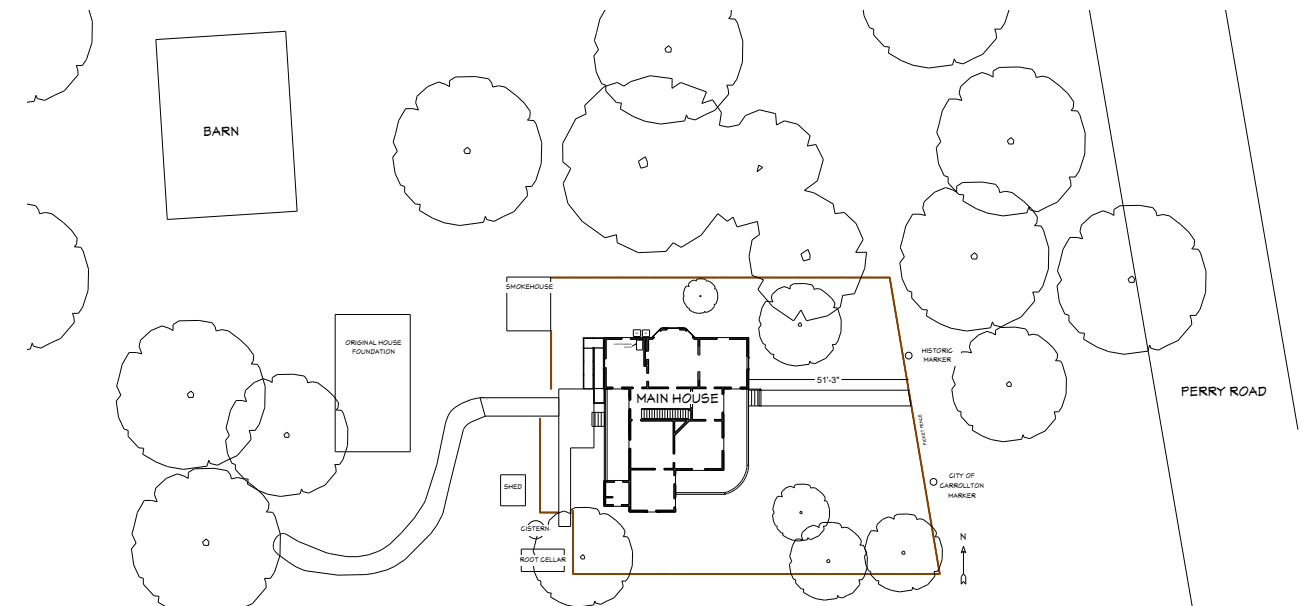
- The Structural Report on the barn presents significant concerns for plans to use it in the future for earned rental income.
- The current condition of the structure renders it unsafe for occupation at this time and requires that it be closed to the public and rendered safe:

- Water has caused and is actively still causing deterioration of the structural wood.
 - Structural members appear to be too small for the load they must carry.

- Connections of members were not properly designed and are coming apart. This could cause horizontal structural pieces to slip off of their vertical supports, or vertical supports to slip off of their foundations, and large pieces of the building could fall.

- The structure is inadequately designed to resist wind or to support much load on the upper level.
- In addition, the barn would need extensive plumbing and electric upgrades to meet health code standards for caterers to serve food.

This barn is not currently suitable for rental events and cannot be easily made suitable. Repairs and rehabilitation of the existing structure could well be more costly than building it anew. Careful consideration of the cost vs. benefits of that plan is recommended.

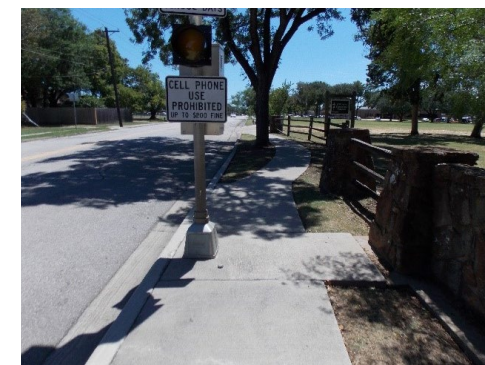
(School Zone Warning Sign)

A flashing school zone warning sign is set in the sidewalk just south of the entrance driveway, and features sign blades that are very close to the limits of the adjacent accessible route. These sign blades could injure an inattentive or distracted pedestrian. A section of sidewalk adjacent to the sign provides enough pedestrian maneuvering space (36" width) to pass it however passage is practically and safely limited to one pedestrian at a time.

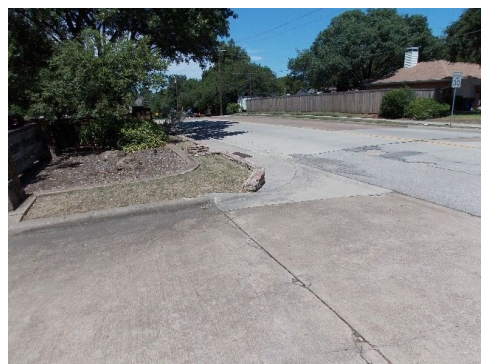
(Monument Sign at Drive Entrance)

At the time of this report, there is no accessible route into the property from the public sidewalk. A pedestrian entering or exiting the site at the entrance drive is forced into vehicular traffic and follow the drive to the ramp at the accessible parking spaces in the parking lot, or to the public sidewalk if leaving. This is the result of a lack of enough space to establish an accessible route along either side of the driveway at Perry Drive, created by two prominent monument signs that flank the driveway. These signs are only 24 inches from the back of the adjacent driveway curb (an accessible route must be a minimum width of 36 inches (TAS)).

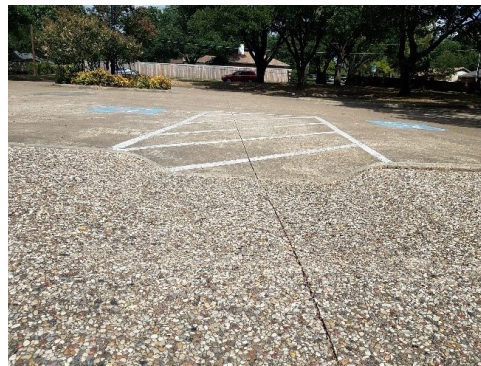
(Curb Ramp)

A single, 4-foot wide ramp is formed into the adjacent pedestrian walk at the head-in curb. Ample landing area is provided at the top of the ramp. The side “flares” of the ramp are excessively steep and there is no contrast in material in the ramp to differentiate it from the integral pedestrian walk. The ramp and pedestrian walk are both constructed of exposed aggregate (pea gravel texture) concrete which is an acceptable and TAS-compliant “firm and stable” surface.

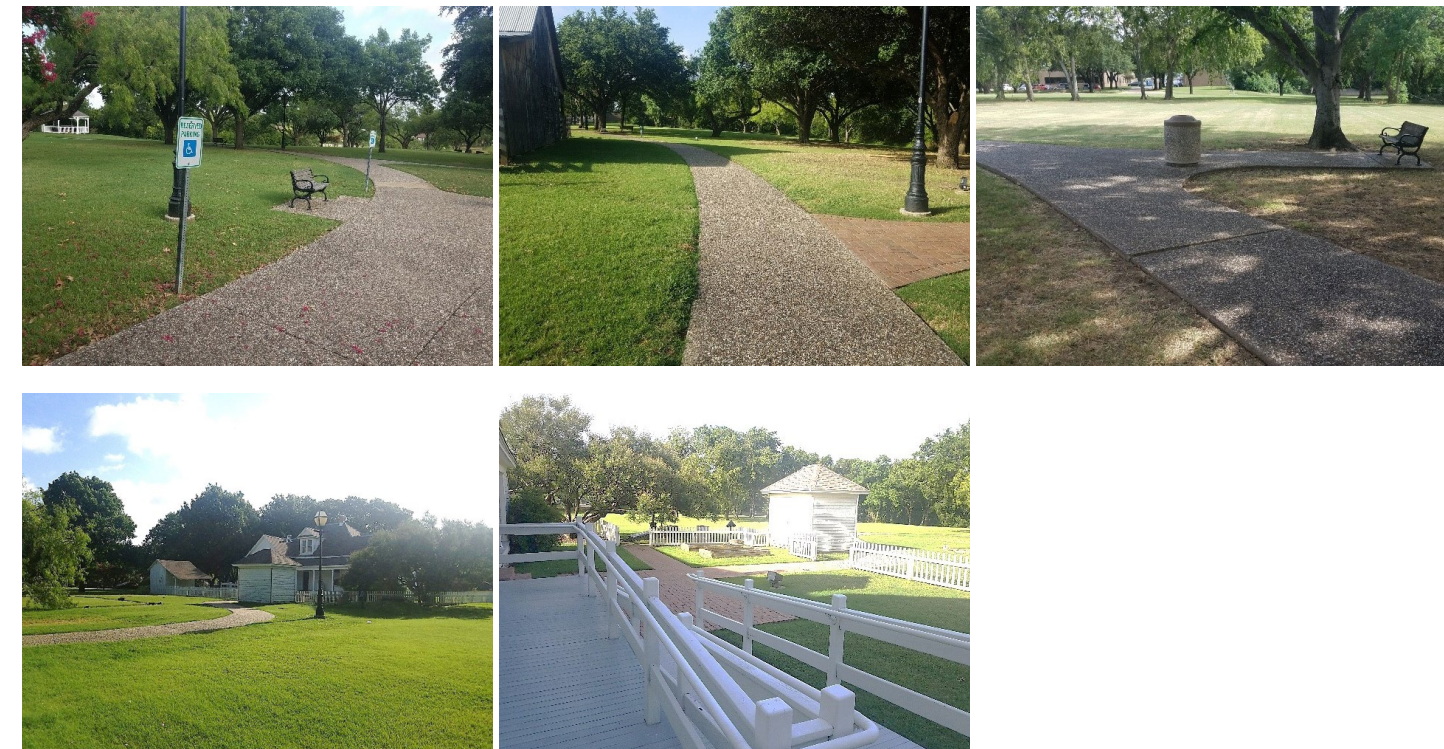
(Pedestrian Route from Parking to Rear of House)

There is currently one pedestrian route from the parking lot to the Perry House which is intended for general and accessible needs. This level to gently sloping route includes a 72-inch wide concrete walk (TAS Section 403.5.3 requires 36-inch minimum) which encompasses most of the homestead grounds, proceeding north and west from the accessible parking, past the gazebo, around the barn, around the former house foundation ruins, and finally to a brick “plaza” and the accessible switch-back ramp which is connected to the back porch. Numerous single-bench seating areas extend off the main walkway and several civic and dedicatory plaques are mounted beside the walk.

Most of the walkway slopes are acceptable and compliant with the maximums prescribed by the TAS. These are the running slopes (5% slope or less) and cross slopes (2% or less) (TAS 403.3). There are several areas that have cross-slopes exceeding the TAS criteria for accessible routes. The pedestrian route does not have posted directional or wayfinding signage at this time that would indicate the direction of travel to the point of accessible entry to the Perry House.

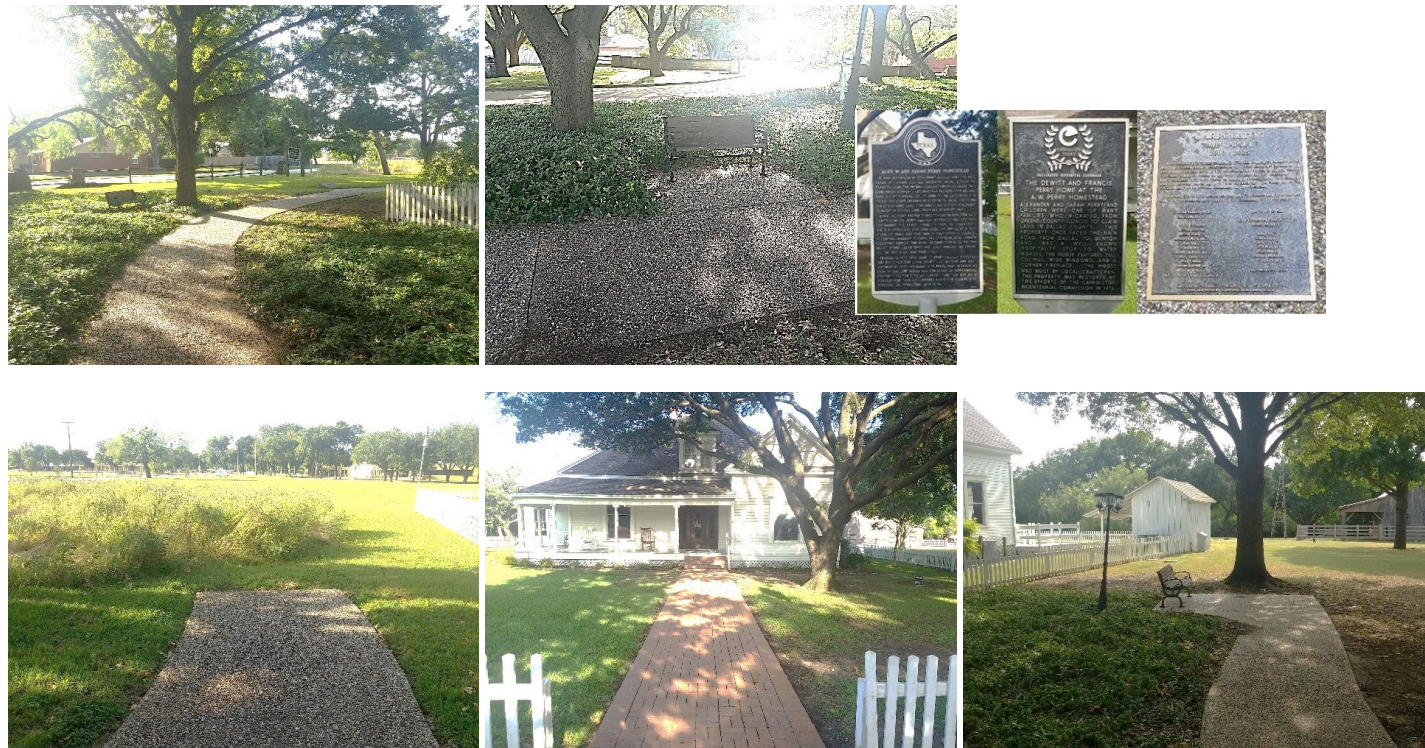
(Pedestrian Route to Front of House)

At the front of the house, a 72-inch wide red brick-paved walk (also accessible in terms of physical characteristics) passes through a picket fence that surrounds the Perry House. This brick walk extends to brick steps that ascend to the wrap-around front veranda/porch and main public entrance to the house. Accessibility ends at the steps as there is not a ramp at the front of the house.

Roughly mid-way between the parking lot and the front of the house, an extension off the walkway to the right (west) leads to a bench underneath a mature shade tree. This walkway can provide a new and shorter accessible route from the accessible parking to the ramp and porch at the rear of the Perry House by continuing the paving through the picket gate at the northwest corner of the fenced yard area around the house and to the brick plaza and existing accessibility provisions (i.e., ramp etc.) at the rear yard. Consulting an arborist can help to determine the best way to route the walk extension to minimize damage to the shade tree.

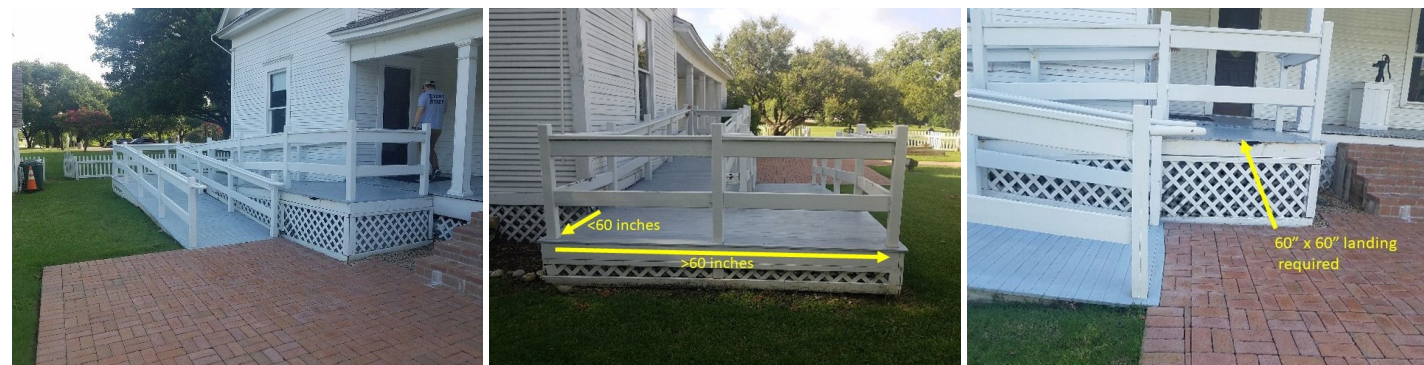
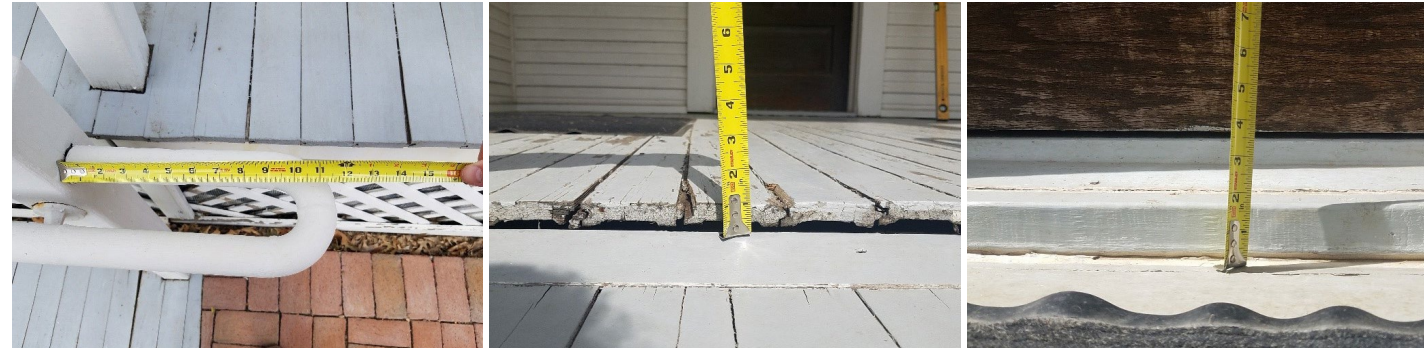
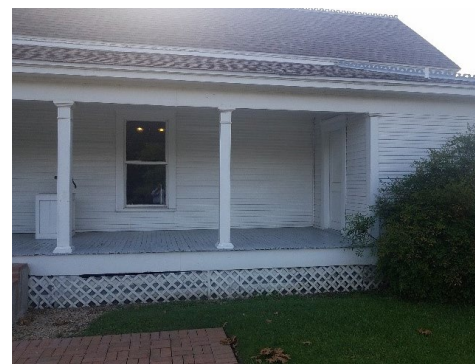
(Access Ramp to Back Porch)

From the porch, access to the interior of the house is by way of a single door at the north end of the porch. Programmatically, the door is left closed during facility hours of operation. Door hardware is an attractive and vintage type (twist-type glass turn knob). The threshold of the doorway is not TAS-compliant and is approximately 3" to 4" high from the porch deck elevation. The door is manually opened (and closed) and it is reasonable within the scope of this evaluation to assume that the pressure to open and close it is minimal. The door hardware (knob) is vintage and requires twisting and is not TAS-compliant.

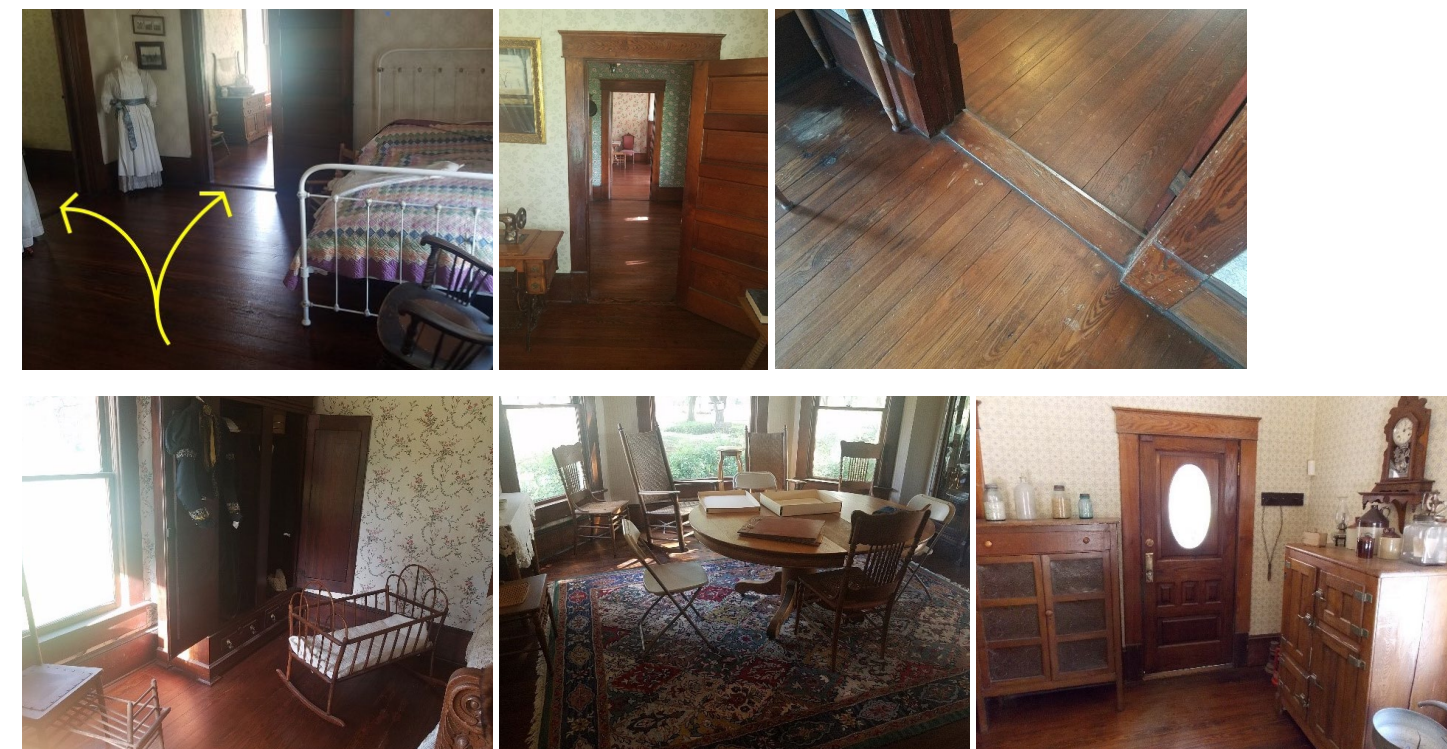
(Perry House Interior, Lower Floor)

Each room on the first floor has a well established tour route by virtue of the placement and arrangement of the items displayed. Inside each room the route is at least 36" wide. Doorway openings throughout the first floor are 32 inches in width except for the door connecting the entry vestibule and the south adjoining bedroom which is 31 inches wide. Vintage wooden thresholds at the doorways are 1 to 2 inches high above the floor elevation (not TAS compliant) and can limit or restrict the independent wheelchair user's passage from one room to another. In general the clear floor space created in each room by the display configurations are adequate for wheelchair maneuverability, although some floor spaces are not wheelchair accessible, for example between a bed and a wardrobe. Nevertheless, a wheelchair user can in all cases get to within a few feet of any space in any room. A Persian rug is noted in the dining room and was found to be less than 1/2 inch in relief above the floor surface. The exit door to the back porch in the rear, is flanked by furniture on both sides. A pie-cabinet is adjacent to the latch side of the doorway which by TAS Standards must have a side clearance of at least 12 inches and a clear floor maneuvering area extending 48 inches from the door into the room. The door hardware (knob) is vintage and requires a twisting motion to operate and is not TAS-compliant.

- Retrofit the interior doorway thresholds with a wooden replacement that mimics the appearance of the original but complies with TAS 302, 303 and 404.5 Changes in Level. (1/2" max. height with bevelled edges.)

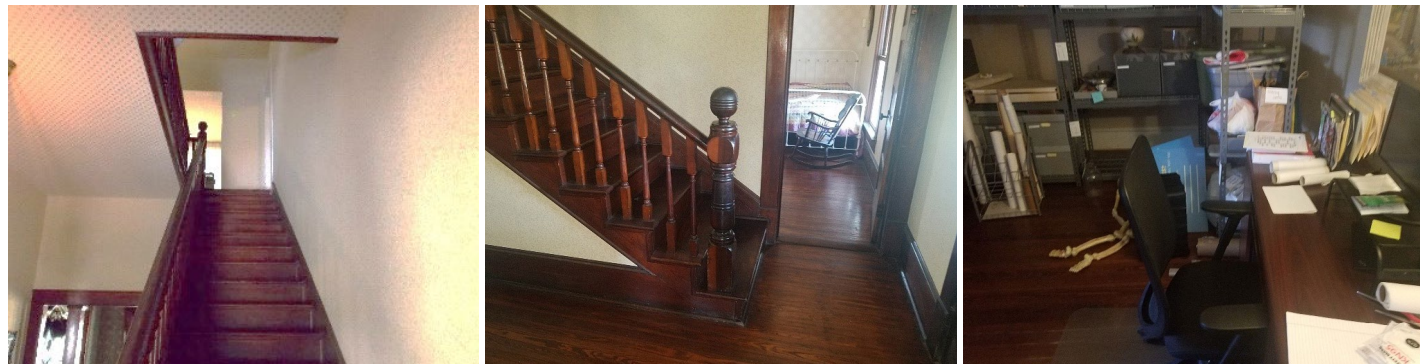
(Perry House Interior, Upper Floor)

The upper floor of the Perry House can be accessed by way of a stairway (no landings) and is not open to the general public. Rather, it is used part-time for staff office space, as well as storage and HVAC mechanical equipment- and is loosely fitted with an informal arrangement of moveable desks, chairs, shelves, filing cabinets and other furnishings. The space is occupied by the Museum Curator who oversees public access to the house and its programming. Additional staff for the Perry House, if hired would reportedly be officed offsite due to insufficient space.

- In such case consider an option that will be least disruptive to the historic and architectural character of the house (e.g., officing on the lower floor, conversion of staff restroom, installation of a staircase chair lift). Note: an outside elevator-type lift would require a "skywalk-type" connection to the interior space; it would impose an architectural anomaly against the historic character and appeal of the house, and may not be structurally feasible due to the offset structural components of the upper floor. Such construction would possibly damage or require removal of one or more trees.

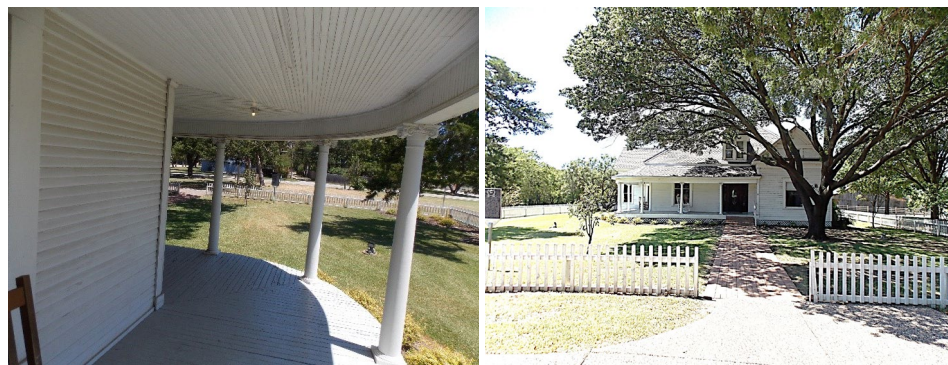
(Front Porch)

The front door threshold, like those throughout the house exceeds the ½ inch TAS maximum height above the floor. Front door hardware (knob) is vintage twist type knob and is also not TAS-compliant). The front porch of the Perry House accessed via the house front door as well as from the front yard and is one of many visual and spatial character-giving elements of the house. The decking of the porch is about 21 inches above the ground below and has no railing or edge protection to keep persons from falling to the ground below.

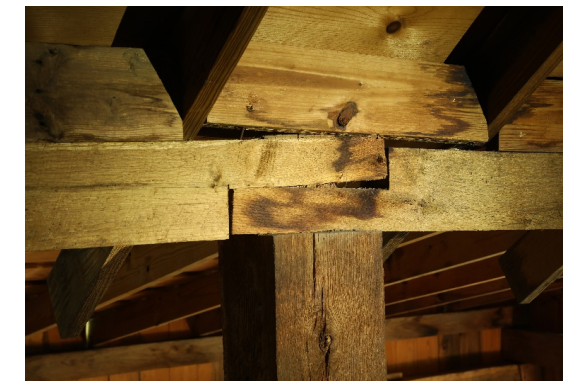
Photo #2

Roof beams (4"x6") appear to be inadequately sized to resist code-required roof live loads and wind loads. Connection of the beams to the supporting columns is not adequate to resist wind uplift forces. Severely-notched ends of the beams further compromise the load-carrying capacities of the beams.

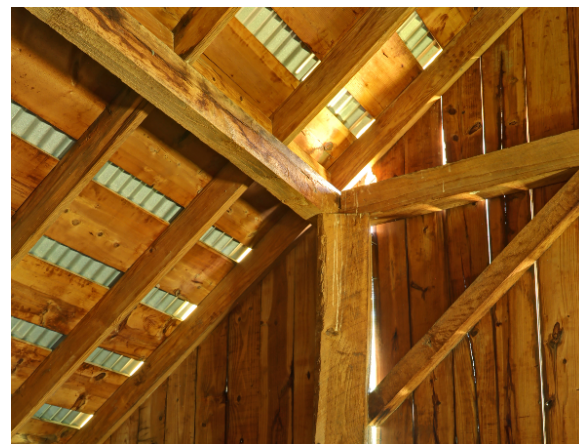
Photo #5

Timber columns above the upper level are twisted about their vertical axis, and are not adequately connected to in-framing beams, nor do they appear to be adequately braced by the in-framing beams.

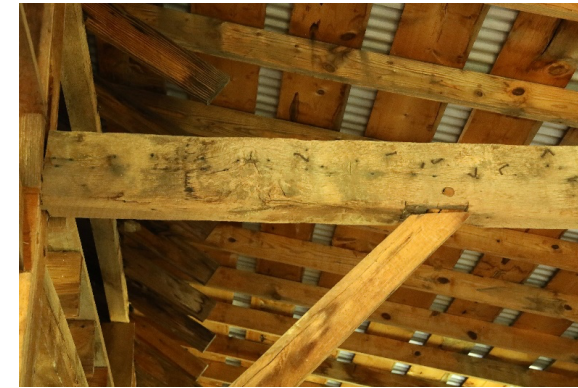
Photo #6

Diagonal bracing connections at some brace-to-beam connections do not appear to be substantially connected. This wood dowel appears to be located very close to the edge of the horizontal member, and to be centered in a split in the end of the diagonal member.

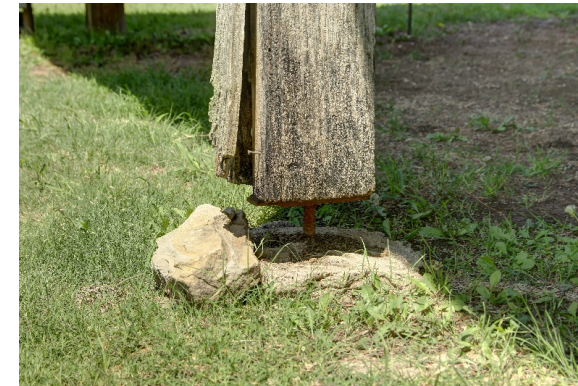
Photo #8

Column bases bear on steel plates welded to one vertical reinforcing bar embedded in concrete piers. Architectural drawings prepared for this building showed the space between the bearing plate and the column grouted solid. Instead, the entire weight supported by this column is transferred to the foundation through a small piece of corroded steel rebar. This does not provide adequate stability for the building, especially under high wind loads and is vulnerable to further rebar corrosion.

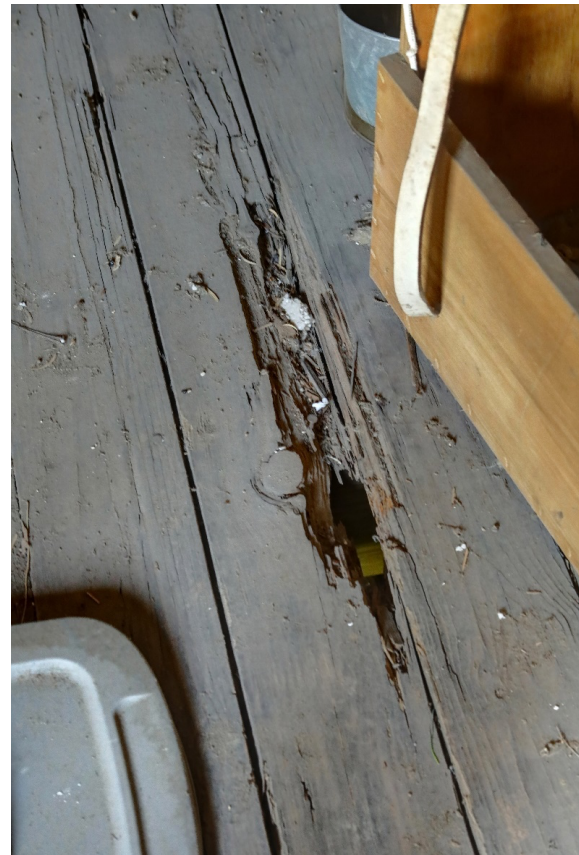
Photo #10

Some areas of the floor deck (this is in a room on the first floor at the northwest corner of the barn) show signs of possible insect damage. A termite inspection may be needed.

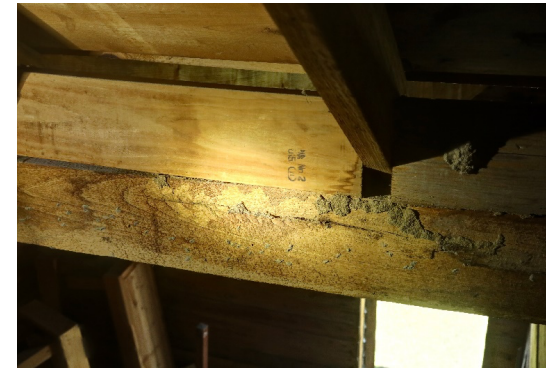
Photo #11

Some areas of the main beam framing show signs of possible insect damage (this is a roof beam above the upper level loft)
